**REQUEST FOR TENDER
ORANGUTAN OUTDOOR EXHIBIT CONSTRUCTION
RFT#: TZC T 10-2020-02
ADDENDUM # 5**

REVISED
Hazardous Building
Materials Assessment

Gaur Pavilion
2000 Meadowvale Road,
Toronto, Ontario

March 26, 2020

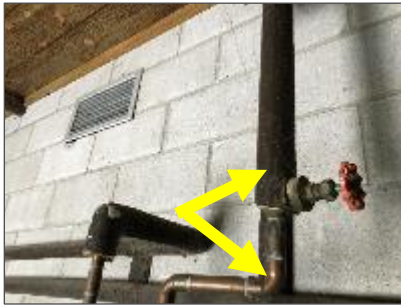
Pipes are either uninsulated (Photo 1) or insulated with fibreglass, jacketed with paper or PVC (Photo 2).

Photo 1: Pipes uninsulated and insulated with fibreglass and jacketed with paper in the Storage / Mechanical / Electrical Room.

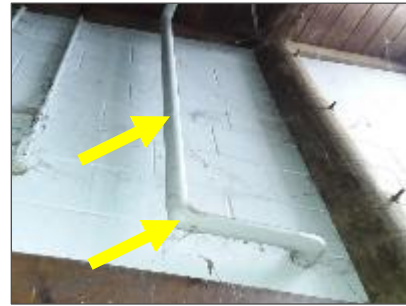
Photo 2: Pipes insulated with fibreglass and jacketed with paper and PVC in the Animal Stalls.

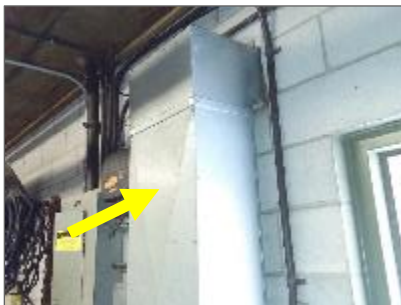
Ducts are uninsulated (Photo 3).

Photo 3: Uninsulated duct in the Storage / Mechanical / Electrical Room.

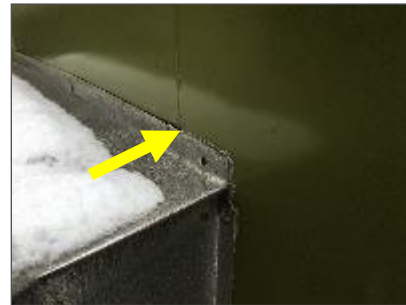
Duct mastic was not observed to be present on ducts within the building. Grey / green duct mastic present on seams / joints on roof ducts associated with the rooftop HVAC units (Photo 4) does not contain asbestos (samples C055473-S0008A-C).

Photo 4: Non-asbestos grey / green mastic on an HVAC unit on the roof.

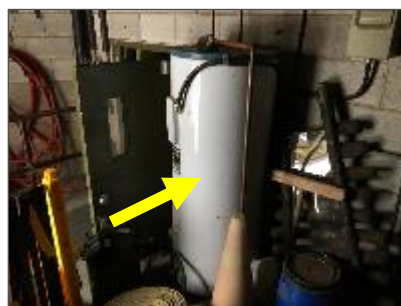
Mechanical equipment (hot water tank, HVAC units) are either uninsulated or insulated with fibreglass and jacketed with metal (Photo 5).

Photo 5: Hot water tank in the Storage / Mechanical / Electrical Room.

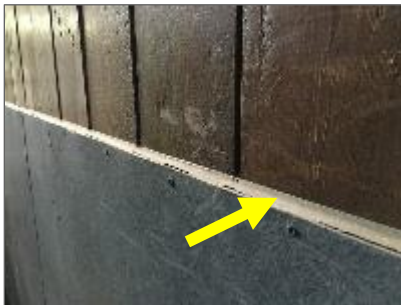
Photo 6: Non-asbestos grey caulking at top of MDF wall panels in the Animal Stalls.

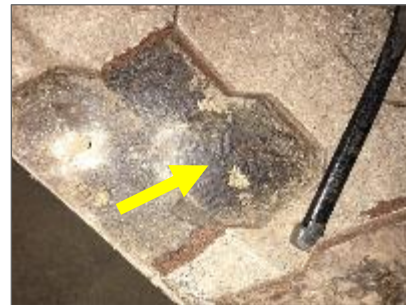
Photo 7: Non-asbestos black / dark brown caulking beneath interlocking rubber flooring in the Animal Stalls.

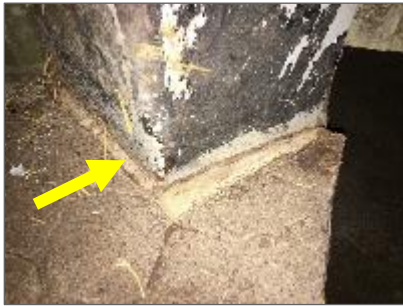
Photo 8: Non-asbestos off-white caulking at the base of metal columns in the Animal Stalls.

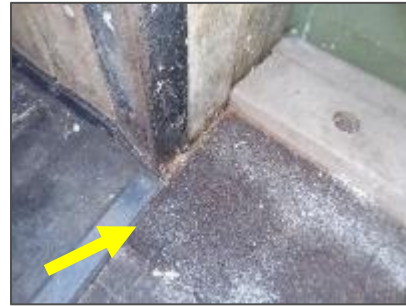
Photo 9: Non-asbestos brown caulking around the carpet floor mats in the Animal Stalls.

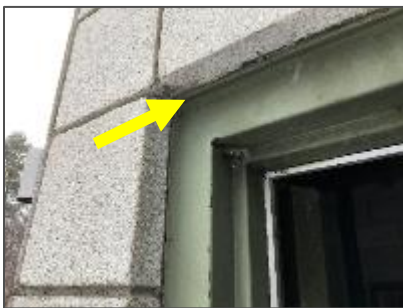
Photo 10: Non-asbestos brown caulking around the metal door frame into the Storage / Mechanical / Electrical Room.

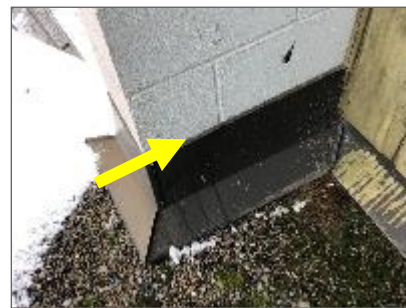
Photo 11: Non-asbestos brown caulking at the top of metal flashing on the roof.

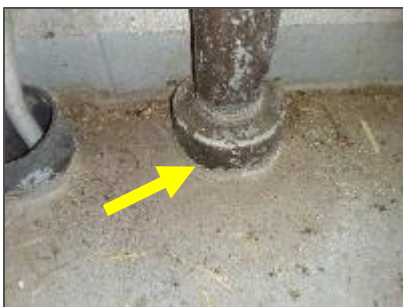
Photo 12: Non-asbestos grey caulking at conduit floor penetrations and the base of walls in the Storage / Mechanical / Electrical Room.

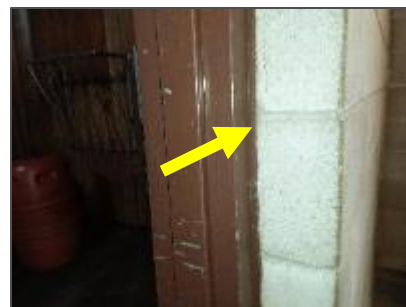
Photo 13: Non-asbestos brown caulking around the metal door frame to the Animal Stalls.

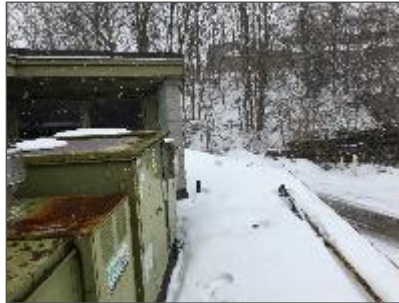
The flat roof section is present over the north portion of the building (Photo 14). The built-up roofing materials were sampled at various locations (samples b227425-S0006A-C and b228437-S0006D-G), and the laboratory detected <0.5% chrysotile asbestos sample b227425-S0006A, *phase c*. All other samples were determined not to contain asbestos. As per O.Reg. 278/05, an asbestos-containing material is a material that contains asbestos at 0.5% or greater by dry weight. Therefore, the roofing materials are not considered to be an asbestos-containing material.

Photo 14: Non-asbestos roofing over the flat portion of the roof.

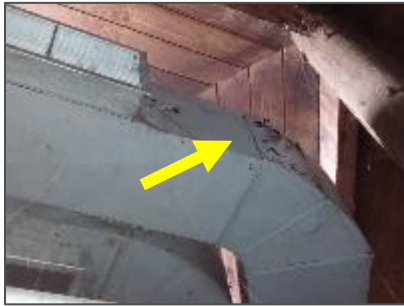
Photo 15: Grey paint on the metal duct in the Animal Stalls.

For paints identified as having low levels of lead (i.e., less than the EACO guideline of 0.1% for lead-containing paints but above 0.009%). Special precautions are not recommended unless aggressive disturbance (grinding, blasting, torching) is planned.

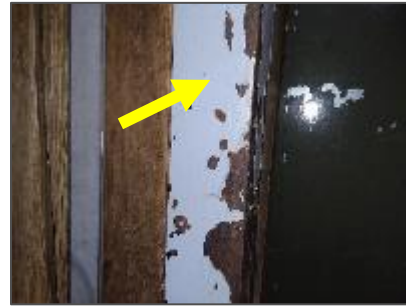
Photo 16: Grey paint on the metal door frame in the Animal Stalls.

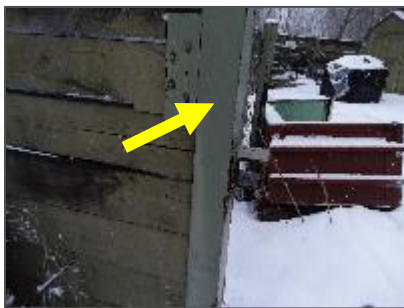
Photo 17: Green paint on the metal post at the exterior south side of the building.

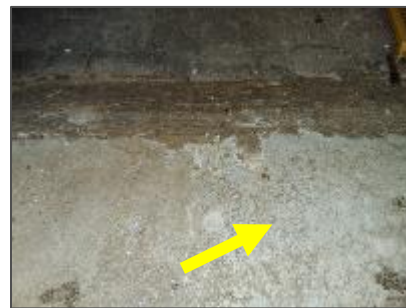
Photo 18: Grey paint on the poured concrete floor in the Storage / Mechanical / Electrical Room.

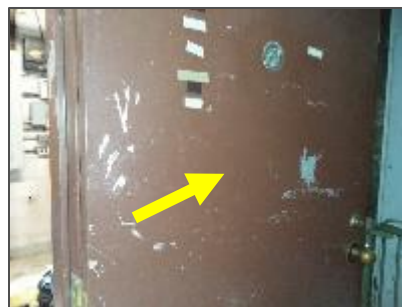
Photo 19: Brown paint on the metal exterior door frame at the entrance to the Storage / Mechanical / Electrical Room.

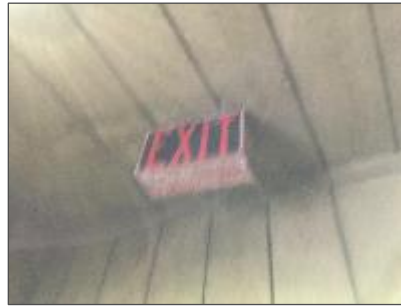
Lead-containing batteries may be present in emergency lighting (Photo 20).

Photo 20: Emergency lighting in the Viewing Area.

Lead-containing items (lead-acid batteries) should be recycled when taken out of service.

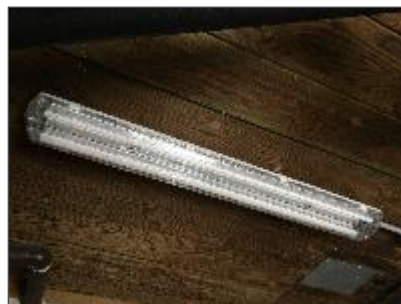
Mercury vapour is present in fluorescent lamps.

Photo 21: Fluorescent lighting in the Storage / Mechanical / Electrical Room.

Do not break lamps. Recycle and reclaim mercury from fluorescent lamps when taken out of service. Mercury is classified as a hazardous waste and must be disposed of in accordance with local regulations.

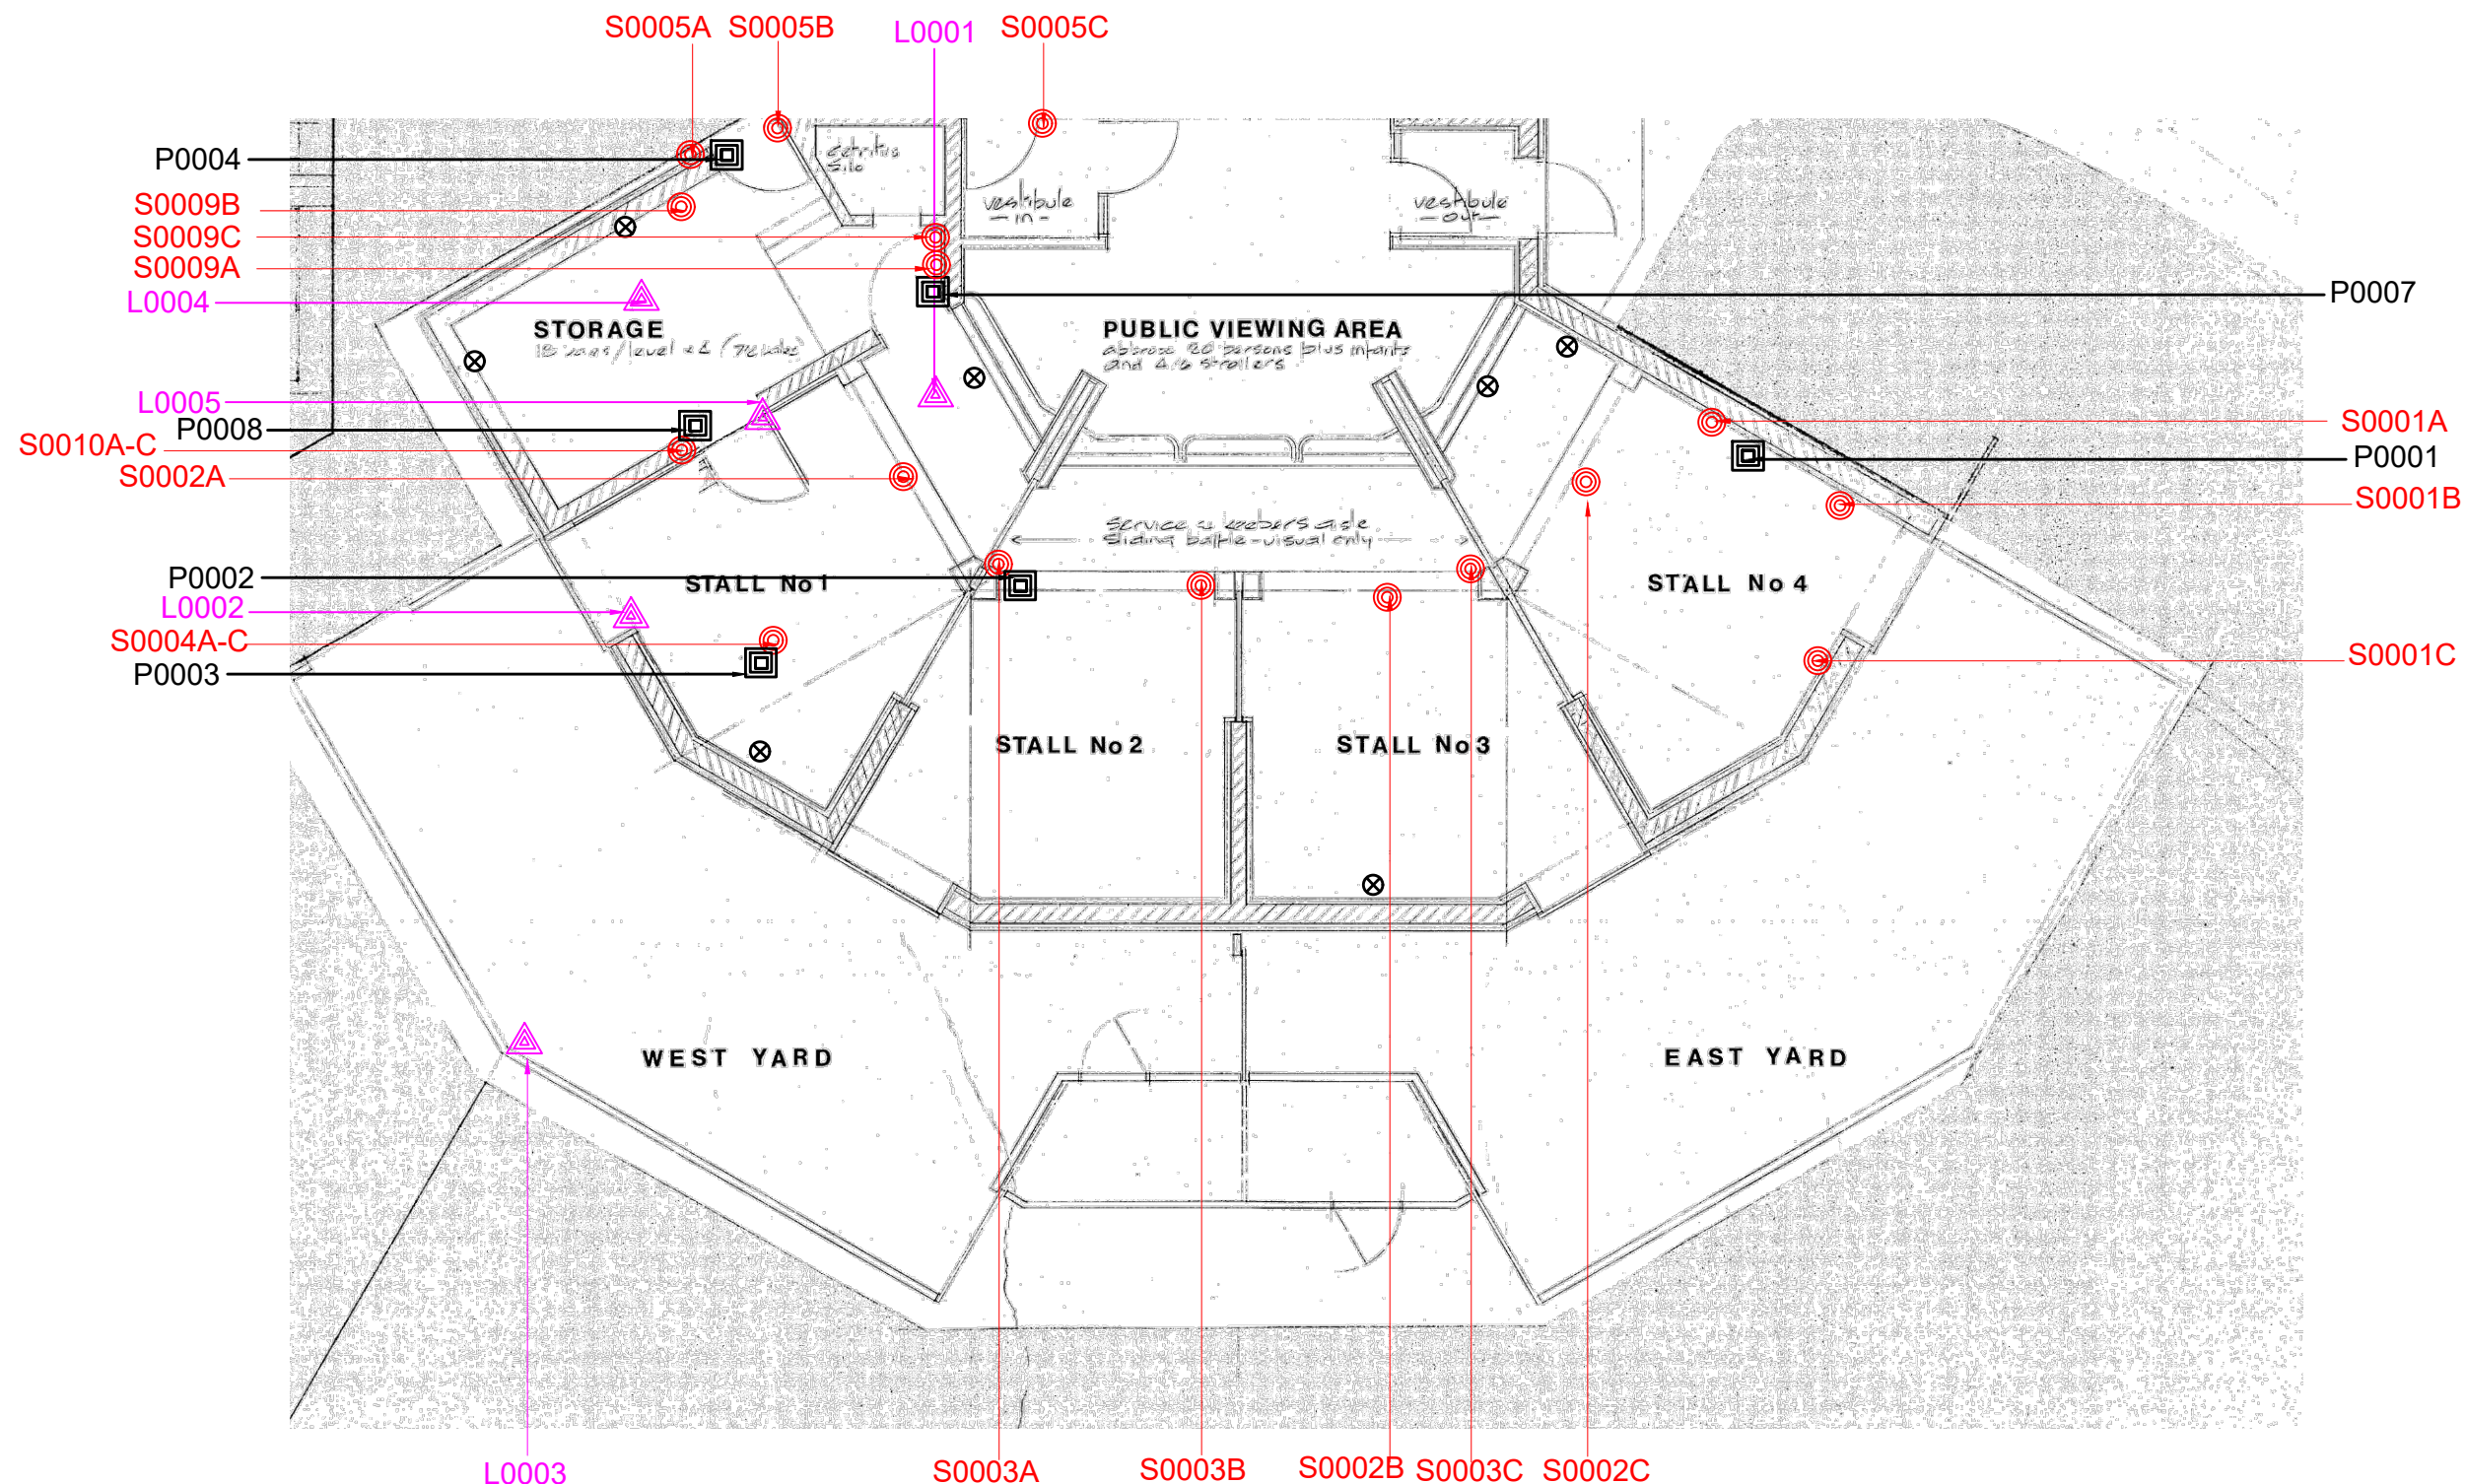
VERMICULITE DRILLING

Destructive testing was conducted of masonry block walls. The masonry block walls were penetrated in 7 locations, and loose fill vermiculite was not observed within the cavities. The locations of destructive testing have been indicated on the drawings in Appendix I.
